An Enhancement to the NA4 Gear Vibration Diagnostic Parameter

Prepared for the
18th Annual Meeting
sponsored by the Vibration Institute
Hershey, Pennsylvania, June 20-23, 1994

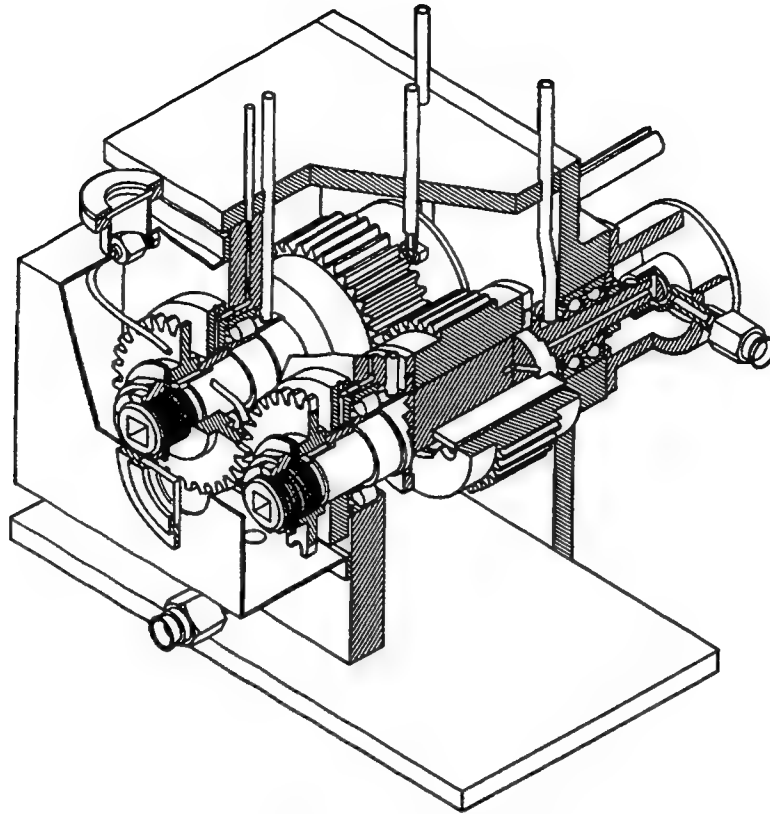
Figure 1.—Spur Gear Fatigue Rig.

The three parameters were tested using data obtained from gear fatigue test rigs at the NASA Lewis Research Center (figures 1 and 2). The purpose of these rigs is to study the effects of gear tooth design, gear materials and lubrication on the fatigue lives of aircraft quality gears. Vibration data from accelerometers mounted on each rig was captured with a personal computer using an analog to digital conversion board and an anti-aliasing filter. Both rigs use the closed loop torque regeneration principle. After the rigs are at operating conditions, the power system only has to supply enough power to overcome the losses in the system.

The spur gear test rig uses a pair of spur gears having 28 teeth, a pitch diameter of 88.9 mm

(3.50 in), and a face width of 6.35 mm (0.25 in). The gear faces are offset by 2.79 mm (0.11 in) to allow a higher surface stress without a corresponding increase in the bending stress. This, coupled with the ability to run on both sides of the profile, allows up to four fatigue failures per pair of gears. The pair transmits 143 kW (192 hp) as the gears rotate at 10,000 revolutions per minute.

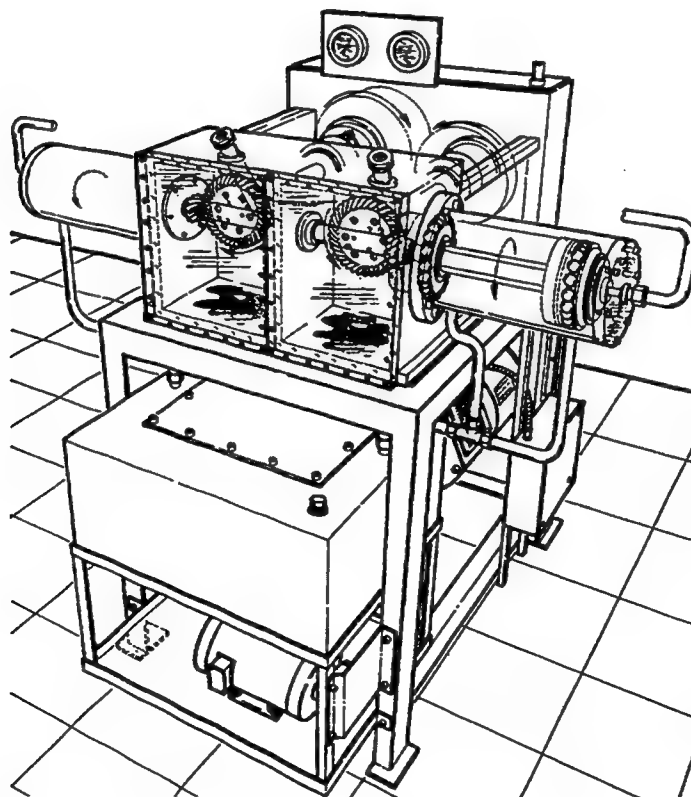
Figure 2.—Spiral Bevel Rig.

The spiral bevel gear test rig uses a 12 tooth test pinion and a 36 tooth gear both having a 35 degree spiral angle, a 25.4 mm (1 in) face width, 90 degree shaft angle, and a 22.5 degree pressure angle. The pair transmits 537 kW (720 hp) as the pinion rotates at 14,400 revolutions per minute.

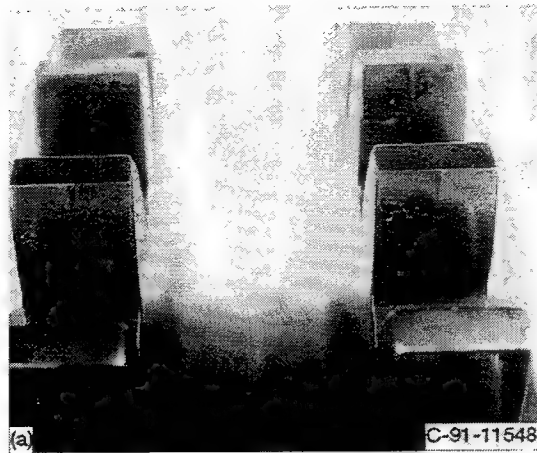
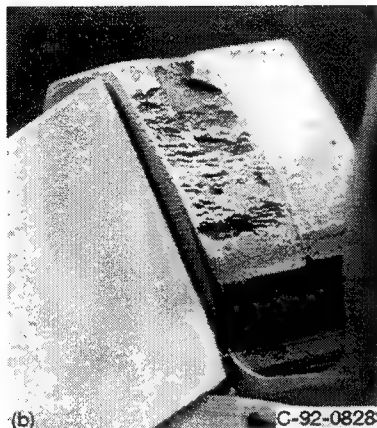
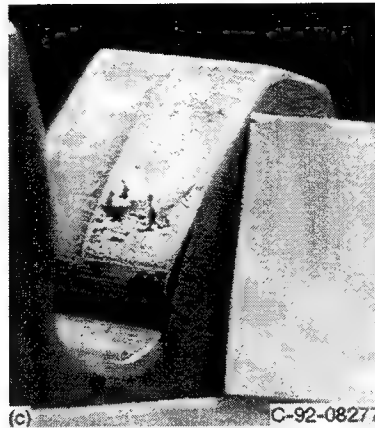
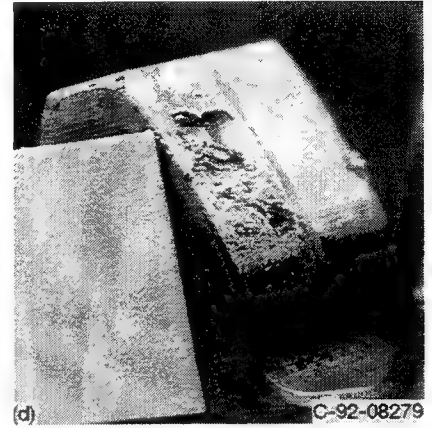
Figure 3.—(a) Heavy pitting on two teeth in Run 1 at 131 hr into run. (b) Example of spalling at end of Run 1. (c) Example of Run 2 moderate pitting. (d) Example of Run 3 heavy pitting.

At 131 hours into run 1, damage was found on two teeth on the driver gear (one heavy and one moderate pitting). Both mating teeth on the driven gear were also found to be damaged (both heavy pitting). Figure 3a illustrates the heavy pitting damage on the driver and driven gears at 131 hours. Figure 3b illustrates the spalling and heavy pitting damage found on roughly one third of the teeth on both the driver and driven gears at the end of the run.

At the end of run 2, damage was found on four consecutive teeth on the driver gear (one heavy and two moderate pitting). Two of the three mating teeth on the driven gear were also

found to be damaged (both moderate pitting). This damage is shown in figure 3c.

Figure 3d shows the damage that was found at the end of run 3. After 74 hours, four consecutive teeth on the driver gear had damage. One was spalled, with two teeth having heavy and one tooth having moderate pitting. One of the four mating teeth on the driven gear was also found to be damaged (moderate pitting).

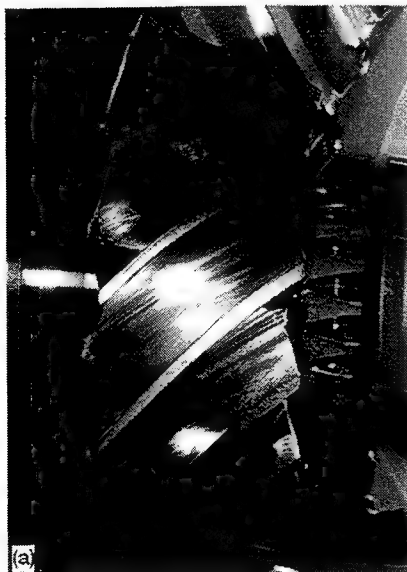
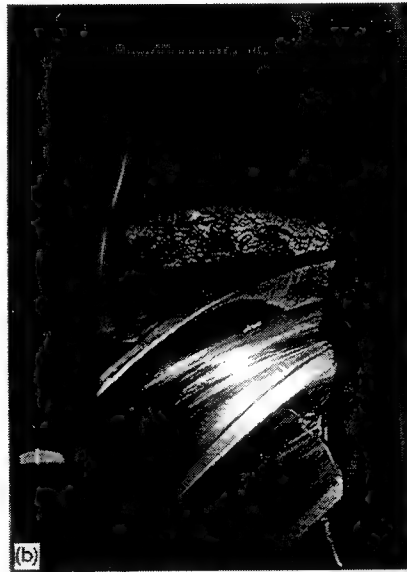
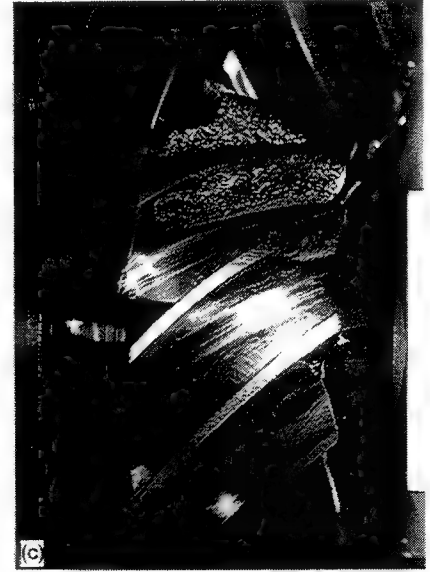
Figure 4.—Damage to Spiral Bevel pinion. (a) At 5.05 hr. (b) At 12.03 hr. (c) At end of run.

Data from one spiral bevel test were obtained. Pictures of tooth damage on the pinion at various stages in the test are illustrated in figures 4a, 4b, and 4c. The rig was shut down a total of eight times to observe and document the damage as it progressed during the run. Only the results of three of these shutdowns will be discussed. At the first shutdown, at about five and one half hours into the test, a small pit was observed on one of the teeth on the test pinion as illustrated in figure 4a. At approximately twelve hours into the run, pitting started to appear on adjacent teeth, as seen in figure 4b. The pitting on the adjacent teeth continued to grow until it covered a majority of the face of three adjacent teeth on the pinion, and part of the face of another adjacent tooth. The run was stopped when one of the three heavily pitted pinion teeth was found to have fractured, losing one-third of the tooth, as illustrated in figure 4c. The fracture occurred between 16.16 and 17.79 hours into the test.

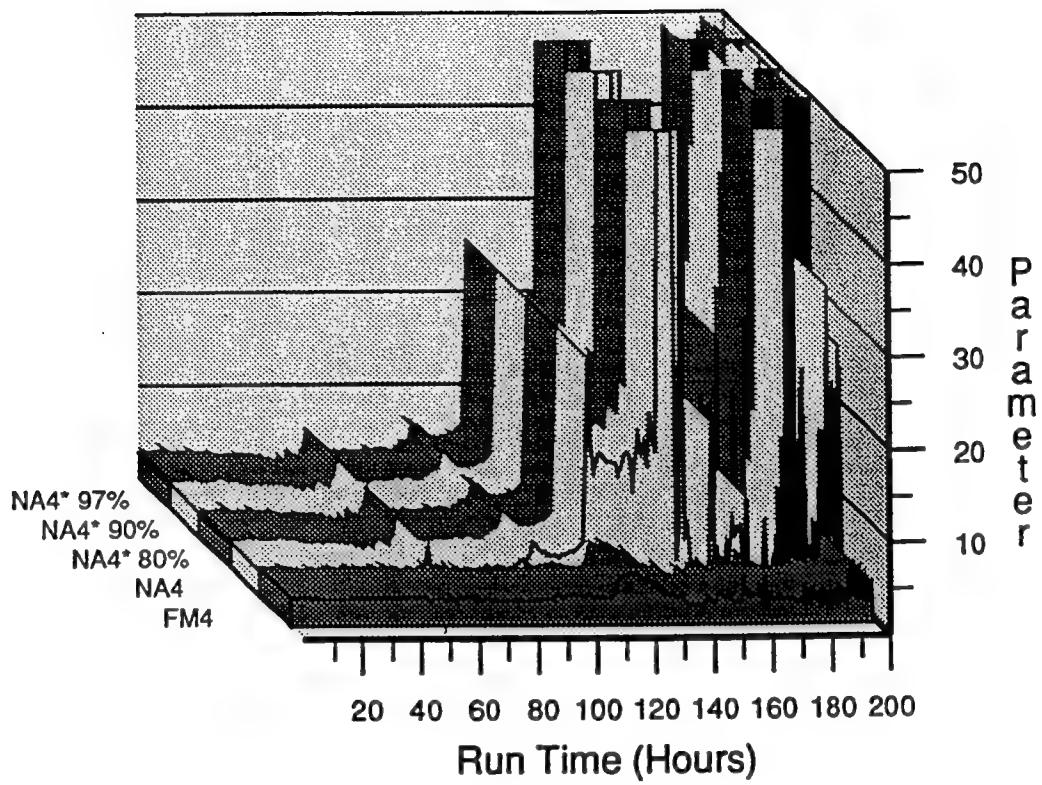
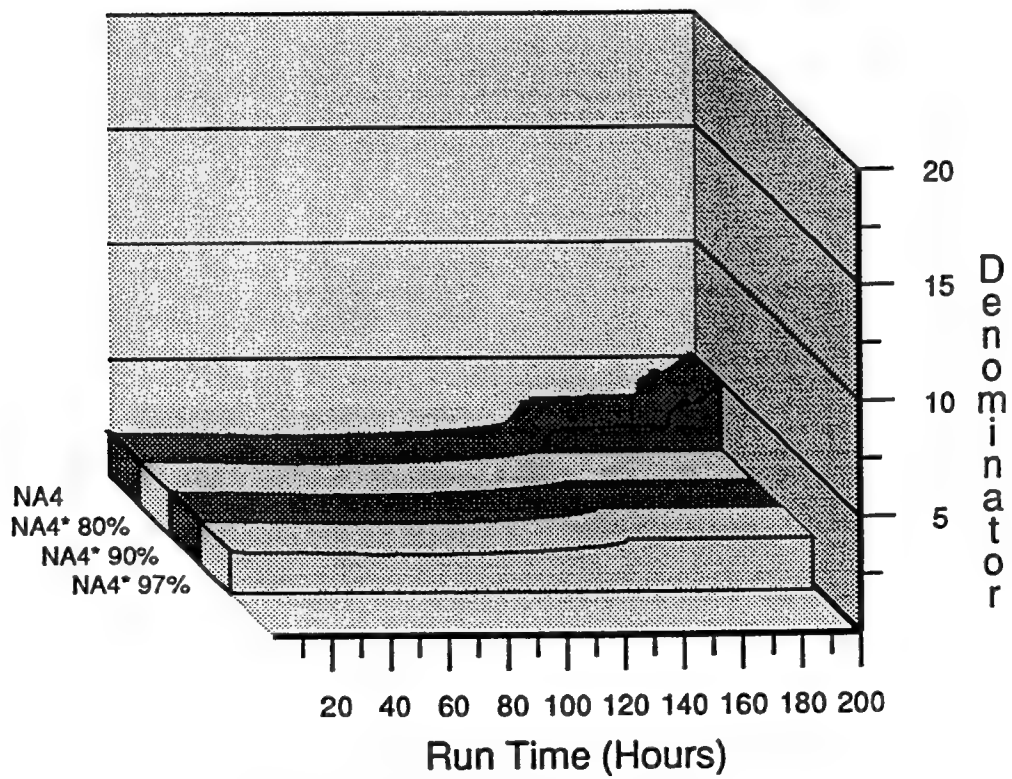
Figure 5.—Parameters for Spur Gear Run 1.

At 131 hours into test 1, the value of the NA4 parameter was very high, the rig was shut down, the gears removed, inspected and photographed. The gears were then re-installed and the test continued. From figure 5, it is assumed that a large amount of damage occurred around 112 hours into the test. NA4 and NA4* both react well to the damage by increasing to a value of 25 and only reducing to a value of 15 as localized damage progressed. FM4, however, peaked to a value of 5.4, then produced a Type I error when it dropped to its nominal value around 3. It is interesting to note that the NA4* parameter does not come

back down to the NA4 level and that the shapes of the curves are nearly identical. This implies that the irregularities of the curve is a function of just the numerator and not both the numerator and denominator. The drastic irregularities that occur after 170 hours are unique to this test and have not been observed in any other test.

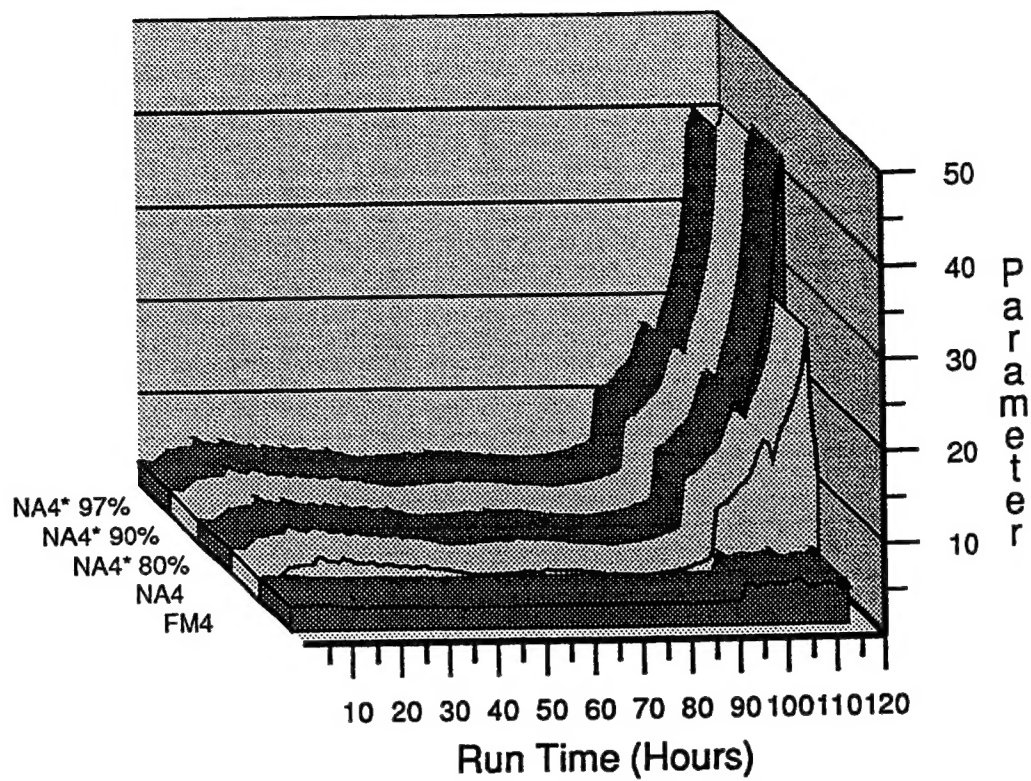
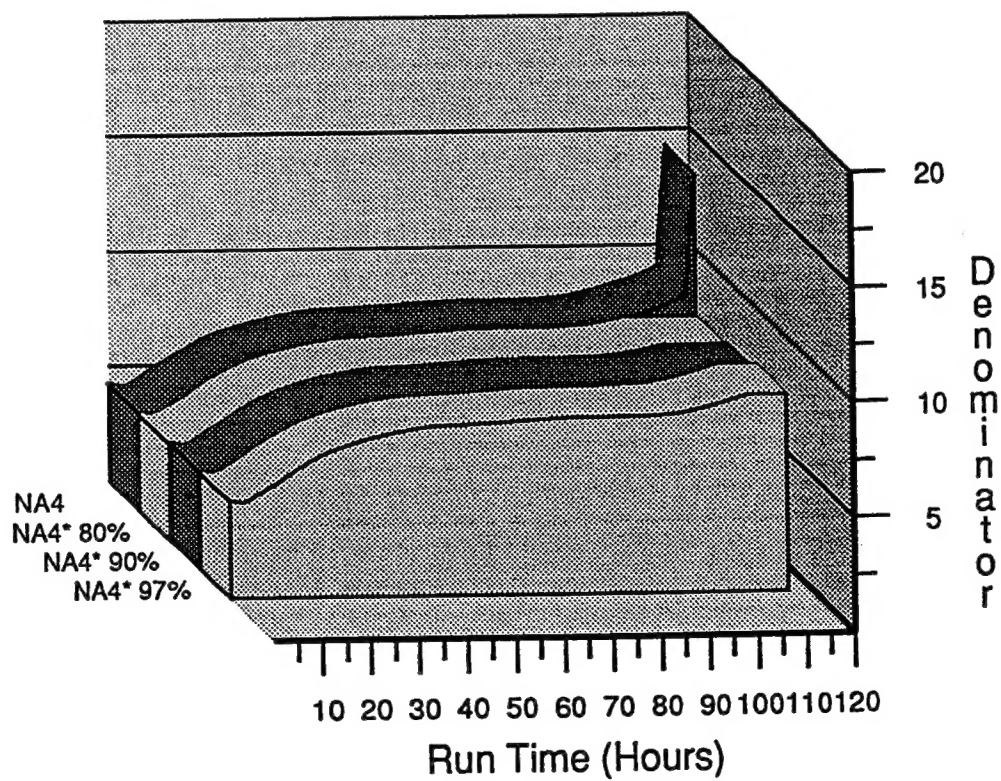
Figure 6.—Parameters for Spur Gear Run 2.

The results from run 2 (figure 6) give the best example of the desired effect of using NA4* versus NA4. The most striking attributes of the curves are the difference in magnitudes and that the NA4* parameter did not give a Type I error. Again, notice that the overall shape of the curve is primarily a function of the numerator. It is interesting to note that the NA4 and FM4 parameters react at the same point in time, although with different sensitivities.

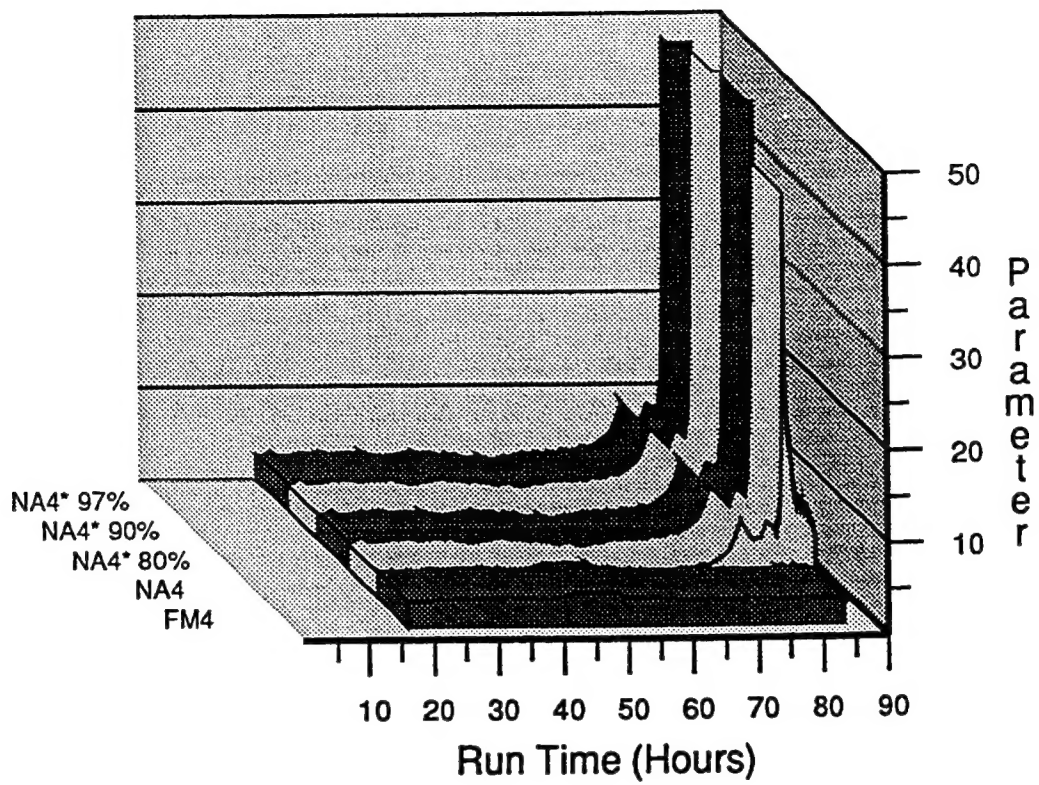
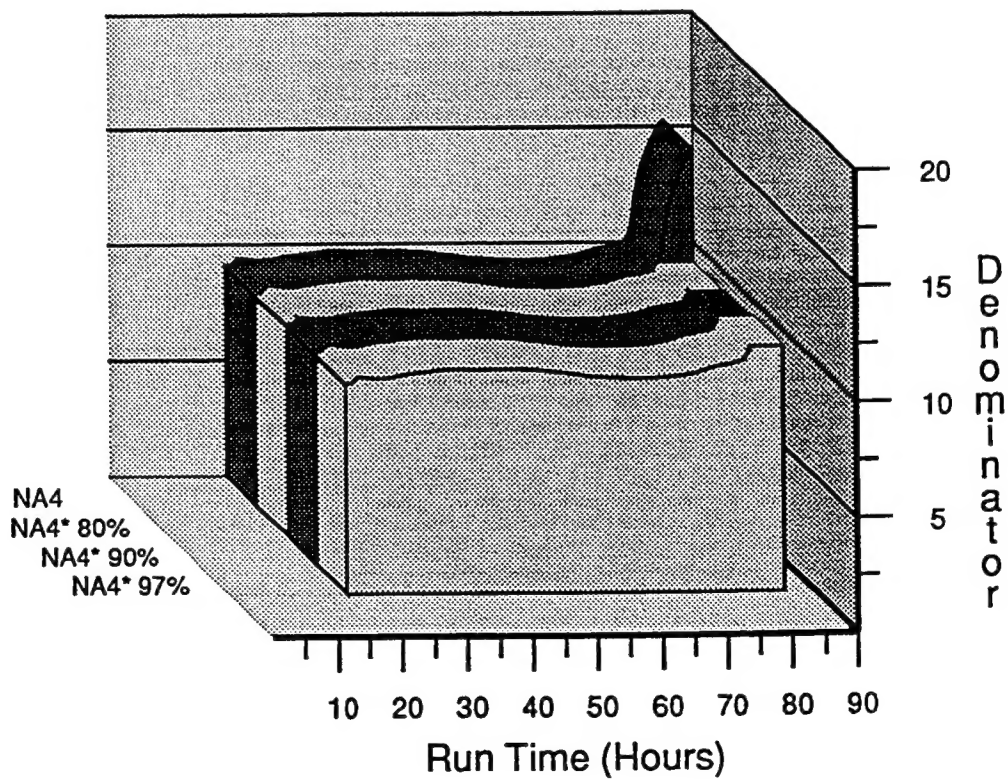
Figure 7.—Parameters for Spur Gear Run 3.

The results from run 3 (figure 7) show the same effect, although not as drastically. The important characteristic to note is that the NA4* parameter is most robust at indicating damage for both the initiation of damage as well as when damage progresses. On the other hand, the FM4 and NA4 parameters may return to levels indicating no damage when actually localized damage is progressing. As with the other runs, FM4 still shows the damage occurring, but it is more susceptible to misinterpretation than NA4 and NA4*.

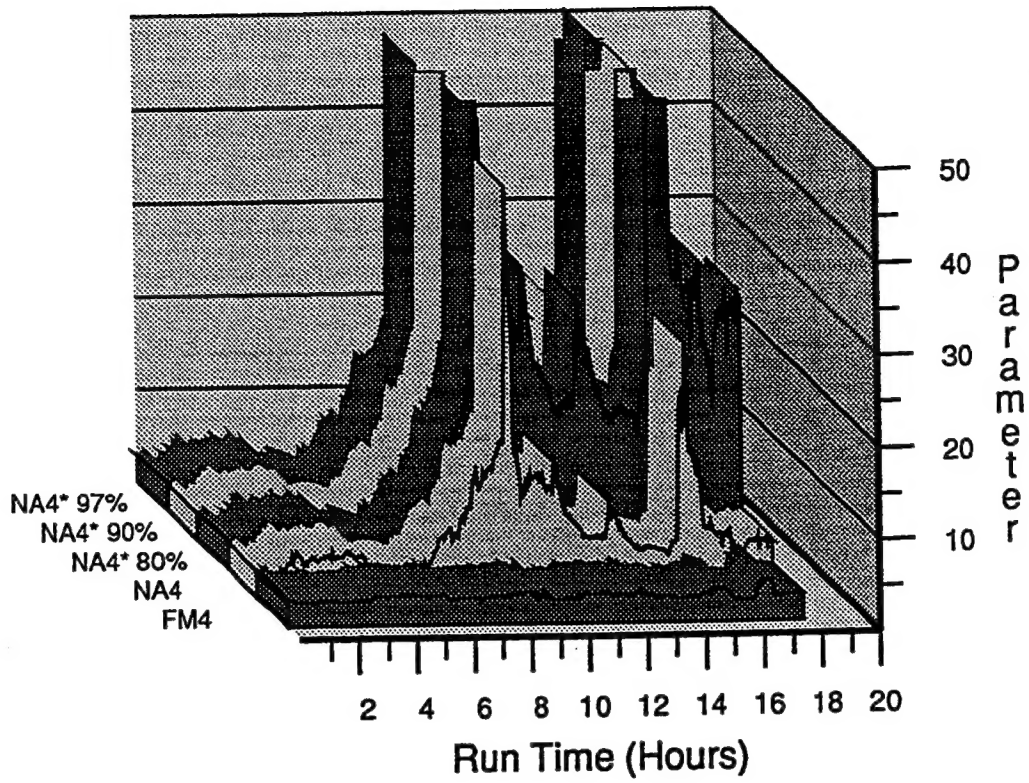
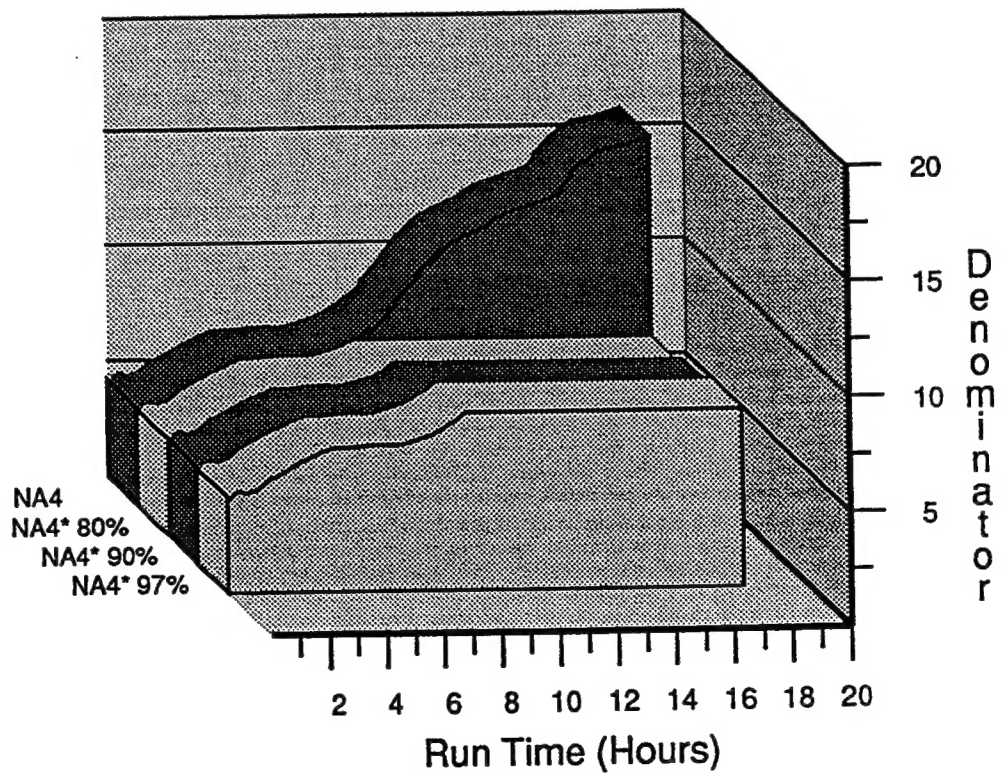
Figure 8.—Parameters for Spiral Bevel Run.

In the results of the spiral bevel test (figure 8), the FM4 parameter did not respond well, only hinting at some damage at about 16 hours. This was well after severe pitting and spalling was documented. For most of the run FM4 was producing a Type I error. The NA4 and NA4* curves give an early and robust indication that damage has occurred. In figure 8, the

effect of using different confidence intervals is best illustrated. In fact, it is suspected that damage started about 1.5 hours into the test when the NA4 and NA4* parameters have a value of near 5 for about 2 hours.

There were some differences in the versions of NA4* corresponding to the selected coefficients. Although a confidence coefficient of 80% is suggested, more experience is needed to determine which produces the best result.
